Manhole Inspection Summary

Manhole # S39G__011MH

Insp Date: **7/14/08 9:31 AM**

Location Address: **115 Albemarle St**

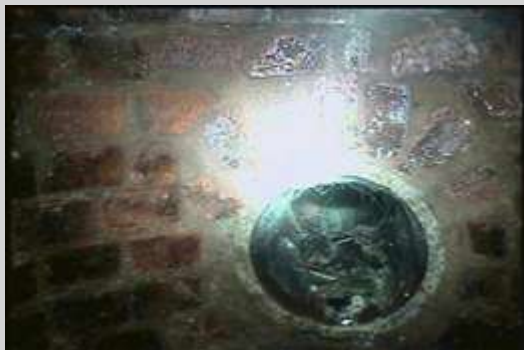
27 in. Circular Gravity Sewer
Drop In @ 12 OClock

the invert vaules are in 6 o clock connectin
because program would not except a drop at
12

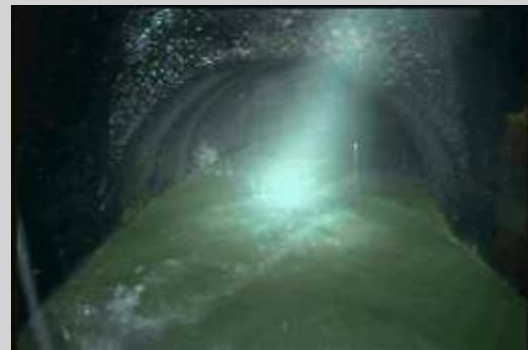
Pipe Out @ 12 OClock

Pipe Material: Clay ☐ Pipe Lined

Invert Depth: 10.47 (ft.) Flow Characteristics: Fast

Infiltration: None Pipe Seal Cond: Unknown

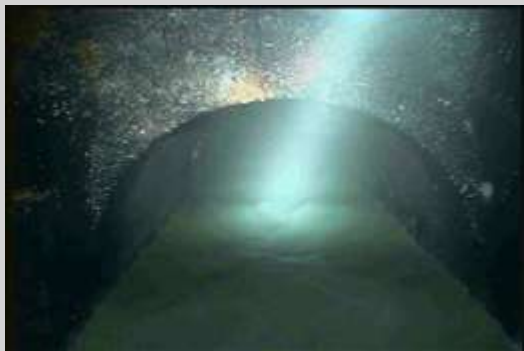
8 in. Circular Gravity Sewer
Pipe In @ 6 OClock

Pipe Material: Clay ☐ Pipe Lined

Invert Depth: 17.00 (ft.) Flow Characteristics: Fast

Drop: Outside Direct

Drop Condition: Open

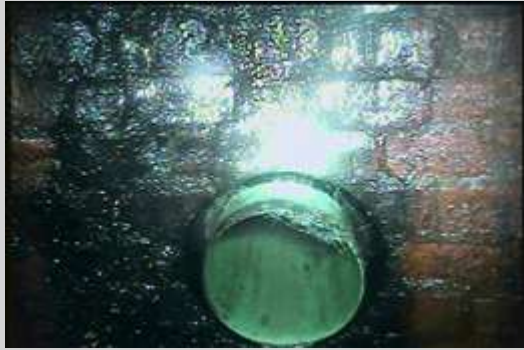
15 in. Circular Gravity Sewer
Pipe In @ 9 O'Clock

Pipe Material: **Clay** ☐ Pipe Lined

Infiltration: **None**
